Customer Services Bulletin
10/12/2020

Kitchen drawer gas ventilation hole - Product Modification Notice

MODEL: All Advance (Series I & II) & Alliance (Series I & SE) motorhomes

Kitchen drawer relief hole procedure

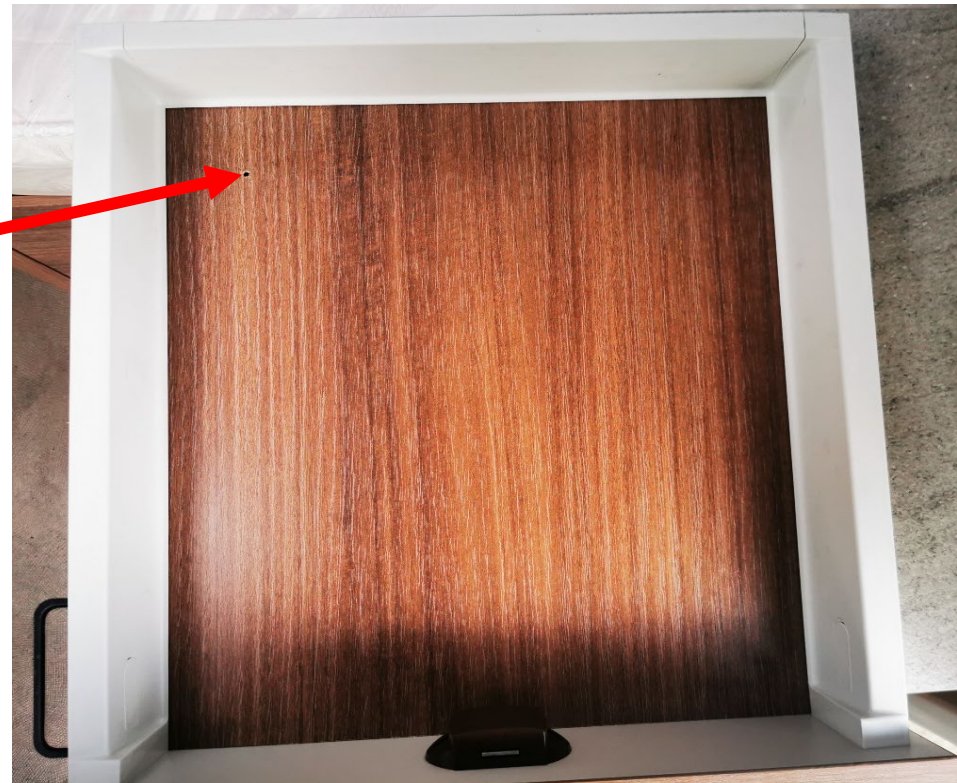
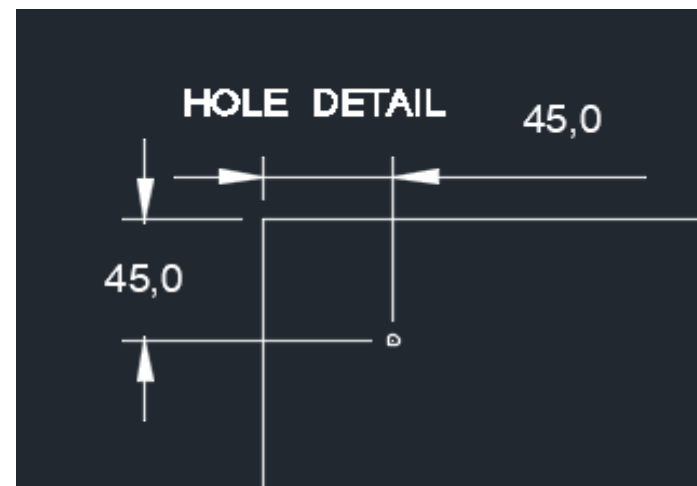
Opp 2	Operation Description:	Visual Aid:
-------	------------------------	-------------

We would like to advise you that during ongoing quality assessment of our product we have identified a possible issue relating to the absence of a gas ventilation hole in certain kitchen drawers fitted in our Advance and Alliance motorhome ranges. In a number of instances, it has been identified that the required ventilation hole in the drawer located underneath the Thetford combination oven and grill has not been drilled out.

Drill a 4mm hole through the base of the drawer in the rear left hand side of the drawer base 45mm in from the back of the drawer and 45mm in from the left hand side of the drawer.

4MM DRILL
