**Date:** 07.02.2020

## **Russell Hobbs Microwave Oven - Product Modification Notice**

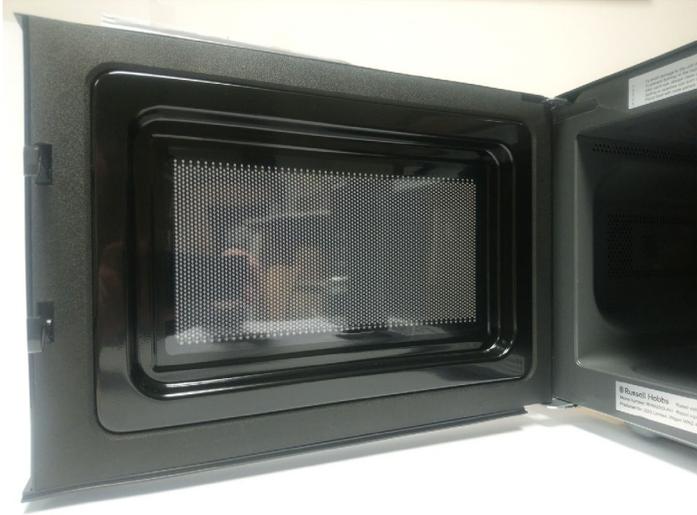
Firstly, open the microwave door and ensure all surfaces are clean from grease.

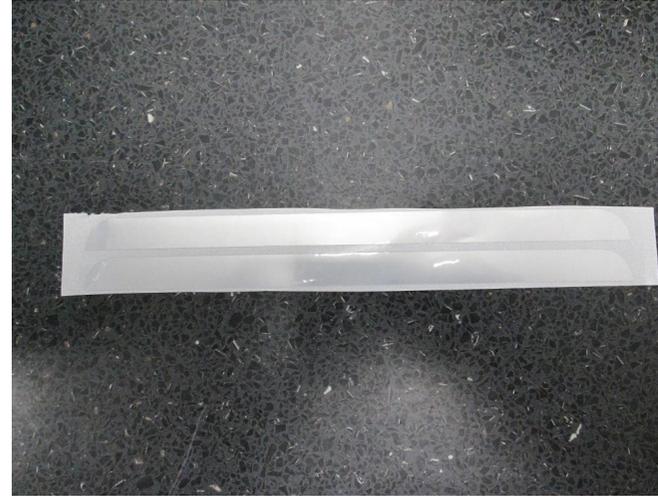
Remove one protective strip at a time from its backing paper.

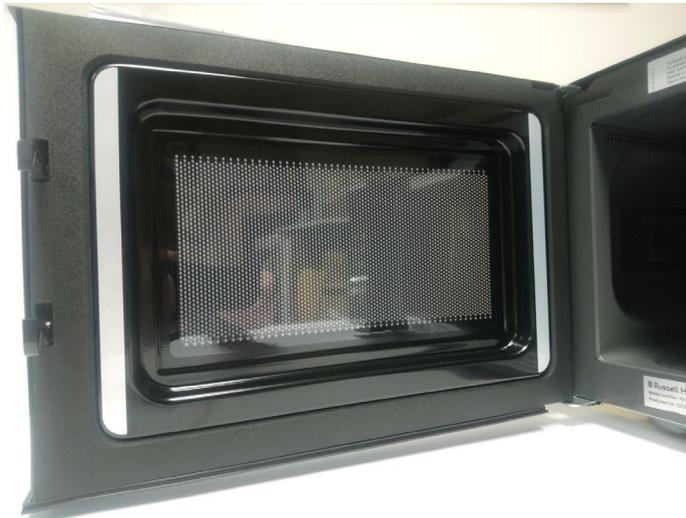
Apply one strip at a time to the inside of the microwave door as shown below.

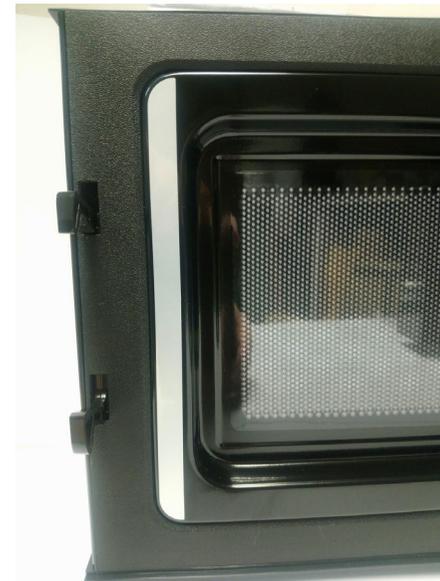
Ensure the protective strips are aligned correctly to the outer edging as shown in the image below.
