Re: Leaking TPMS valves

Quality Alert – TPMS Valves

Problem Definition

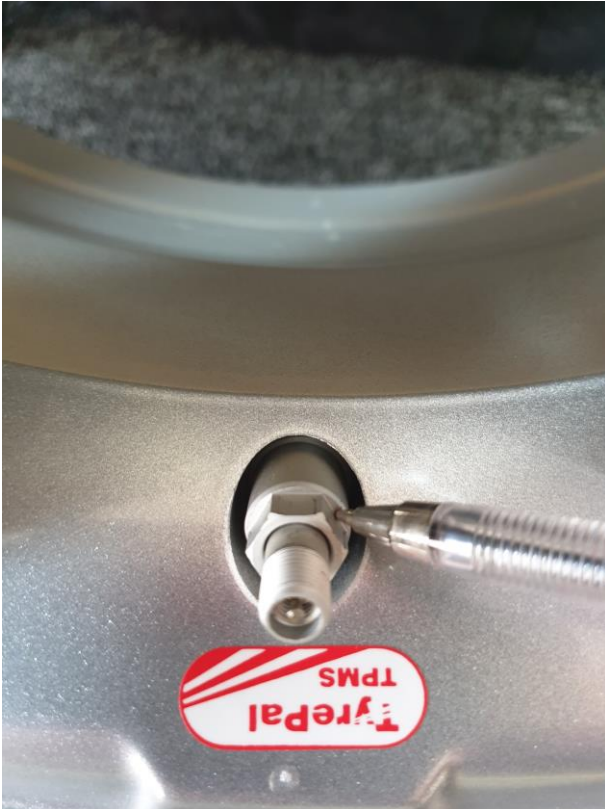
TPMS Valve Nut Collar

Check the torque of the valve retaining collar nut

There is a small possibility that tyre deflation could occur as a result of incorrect torque application to the TPMS valve nut on Bailey Unicorn and Alicanto caravan models produced between August 24th through to September 15th.

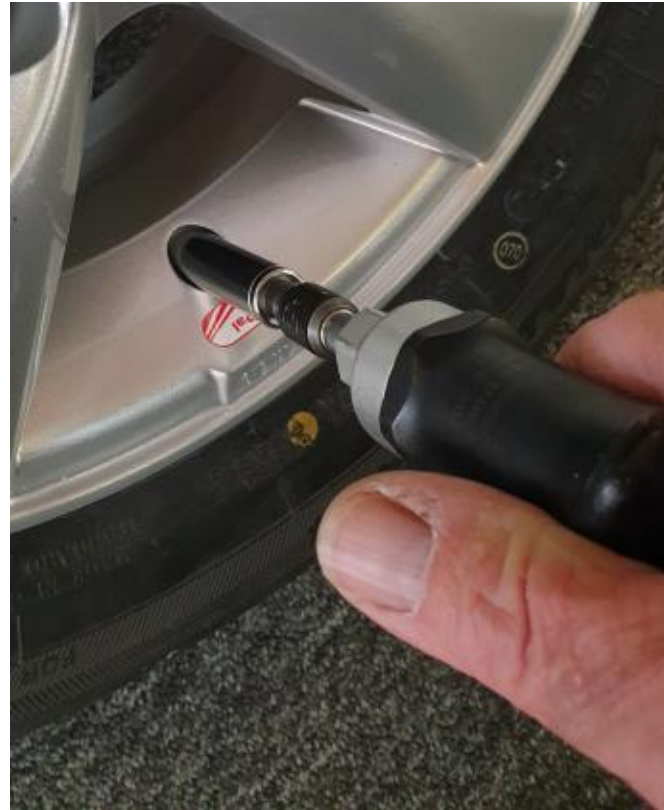
Torque wrench with 11mm deep socket

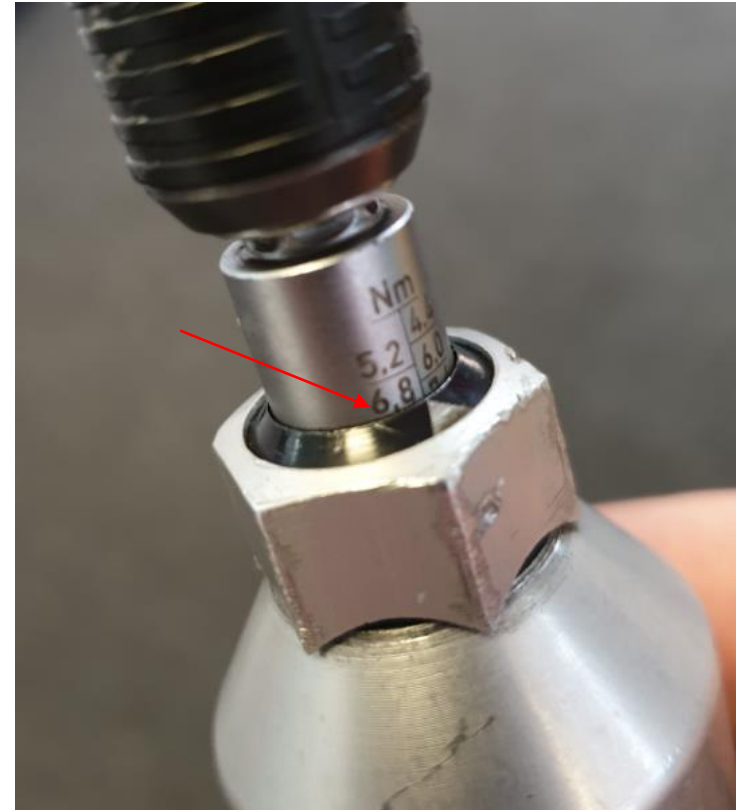
The correct torque setting is 6.8Nm

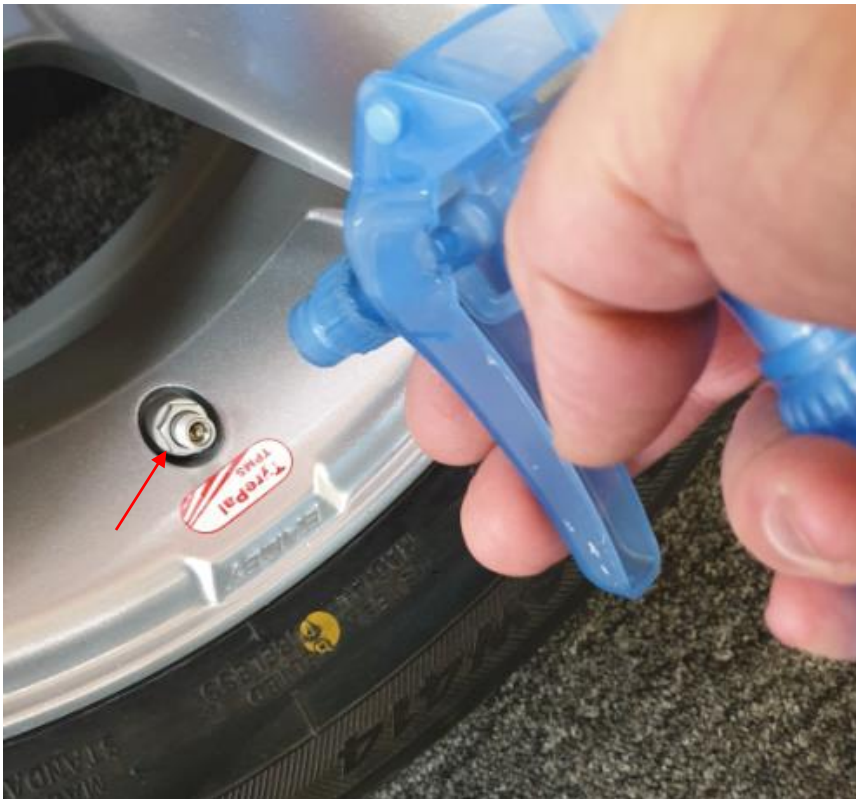
Once the torque check has been completed, test for escaping air by using soapy water, sprayed around the valve collar nut.

Apply soapy water

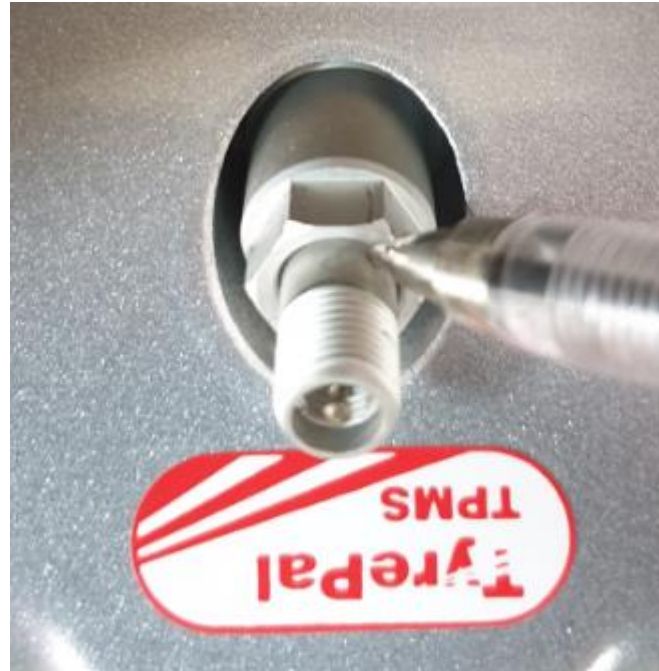
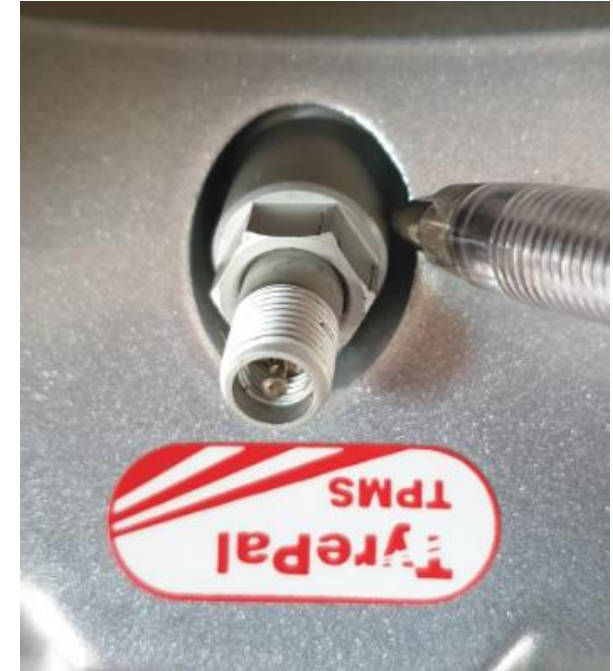
Apply where shown in the pics below

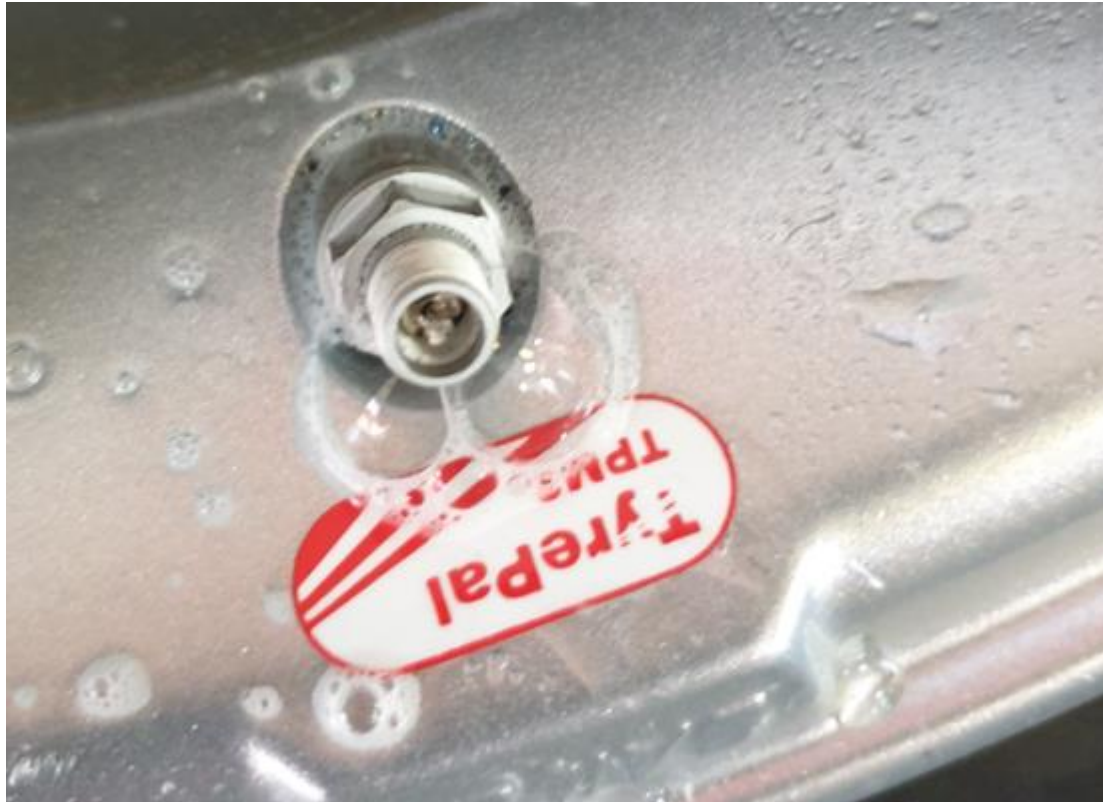
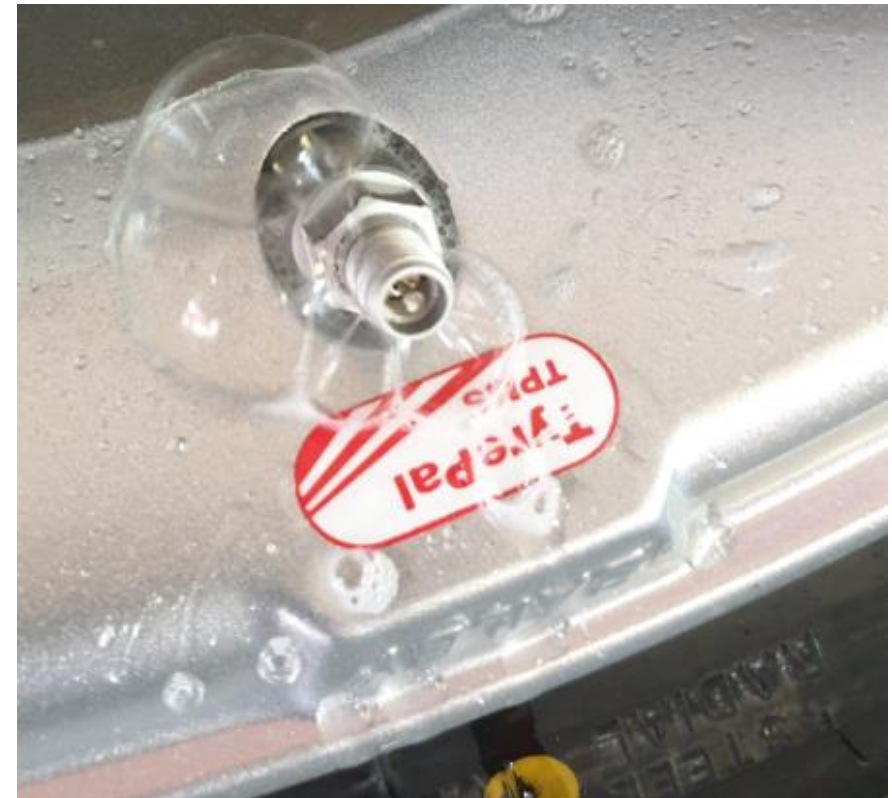
Once the soapy water has been applied, look for bubbles – for a minimum of 20 seconds.

If air is escaping, bubbles will form

But if bubbles form during the leak test, the wheel should be replaced before the caravan is towed.

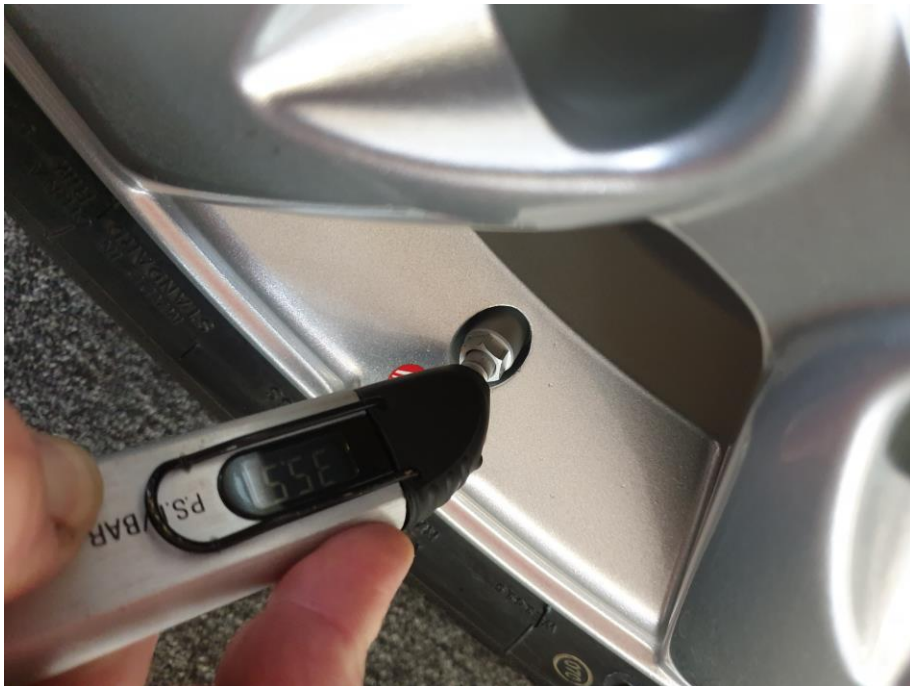
Tyre Pressure Check

Once the leak test has been completed, and assuming that no air is escaping, check the tyre pressure.
